# IN-SITU REMEDIATION ON AN OPERATIONAL DEPOT SITE

## Case Study

**Executive Summary**  
In-situ remediation scheme to manage legacy diesel contamination arising from historic refueling operations, within a live operational distribution depot.

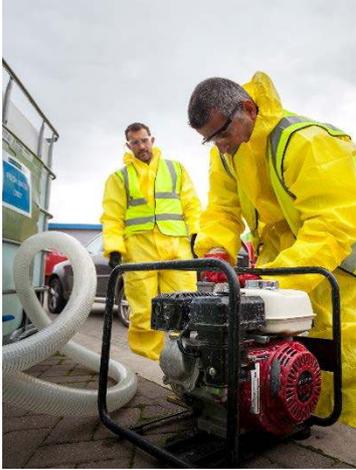
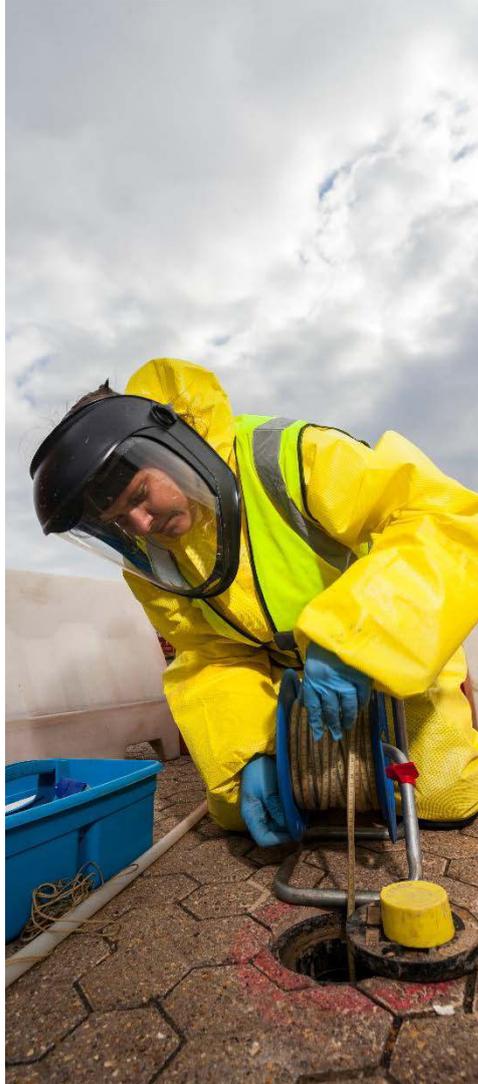
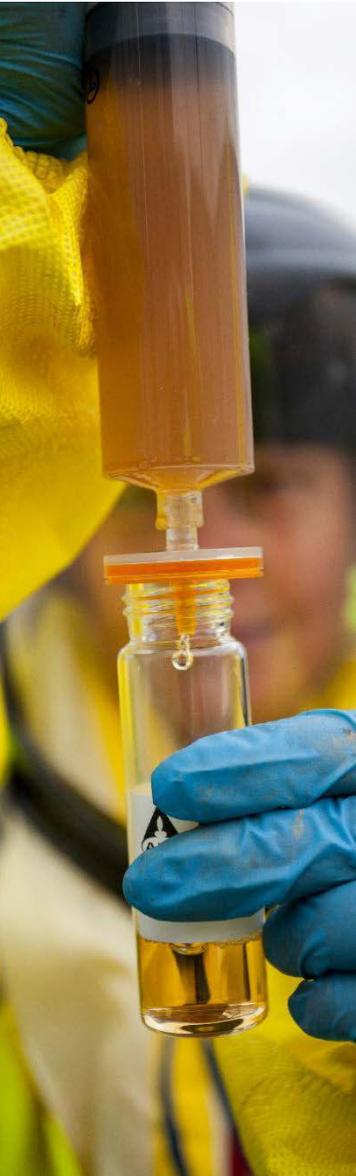
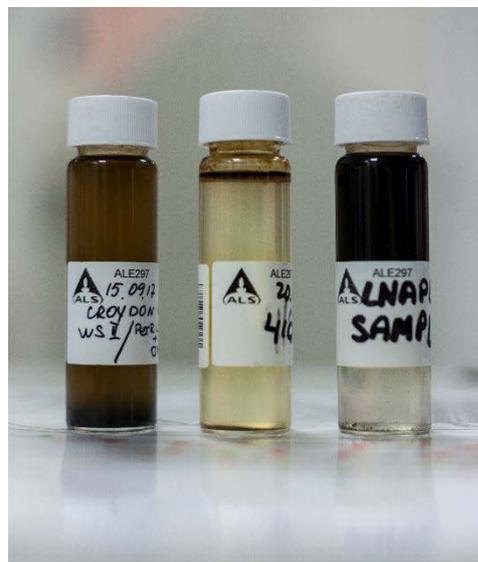
The deployed remediation system incorporated a compact batching plant. This enabled the treatment area to be established with a small operational footprint with an appropriate level of security. An appropriate balance to management of on-site safety with a negligible impact on HGV and commercial vehicle on-site logistics was achieved.

The injection infrastructure selected provided a low-cost solution which did not demand any disruptive enabling works for the installation of buried manifolds and therefore consequently avoided onerous reinstatement costs.

The system of pipework and fittings selected enabled rapid assembly and dismantling of the delivery/recovery infrastructure to each of the injection and monitoring locations.
